Longitudinal Sway Brace Assemblies

A Common Fitting Misapplication

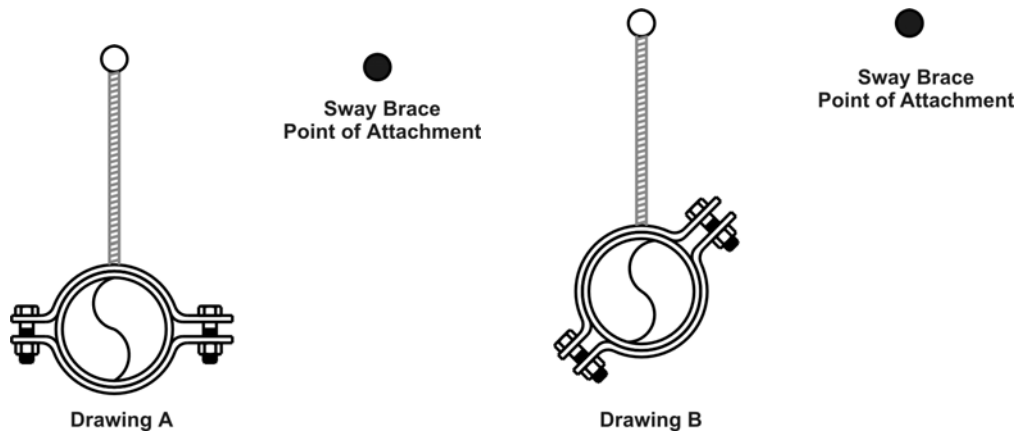
When the structure dictates a point of attachment that is not directly above the system pipe, sway brace alignment may become problematic. The offset dimension of the sway brace point of attachment may conflict with the optics of correct longitudinal sway brace alignment and could be harder to quantify. Whether for aesthetics of assembly, because they believe it looks better, or poor judgment fitters often rotate the mounting of the longitudinal sway brace fitting to horizontal with its fastener flanges at 90 degrees. **See drawing A.** This positions the sway brace assembly on a conflicting axis with the system pipe rather than the required NFPA 13 parallel axis. To correct this common fitting misapplication the axis of this sway brace assembly must be rotated into the same plane as the centerline of the system pipe.

Further, listings of longitudinal sway brace fittings require the brace member be aligned parallel to the face of the fastener flanges, thus loading them from their edge as they are stronger in this orientation than against their flat. Improper mounting of the longitudinal sway brace fitting can cause non-axial loading on its structure resulting in reduced ability due to bending or twisting.

Adjusting the mounting position of the longitudinal sway brace fitting will correct both the misalignment of sway brace fitting and the misalignment of the brace pipe. The fitter should rotate the fitting mounting position to align or index the fitting fastener flanges on a straight sight line toward the point of sway brace attachment to the structure, just like the hands on a clock. **See drawing B.** Now the sway brace point of attachment to the system pipe is aligned with its point of attachment to the structure creating a proper parallel axis in conformance to NFPA 13.
